issue brief

HEADACHES AT PALISADES: BROKEN SEALS & FAILED HEALS

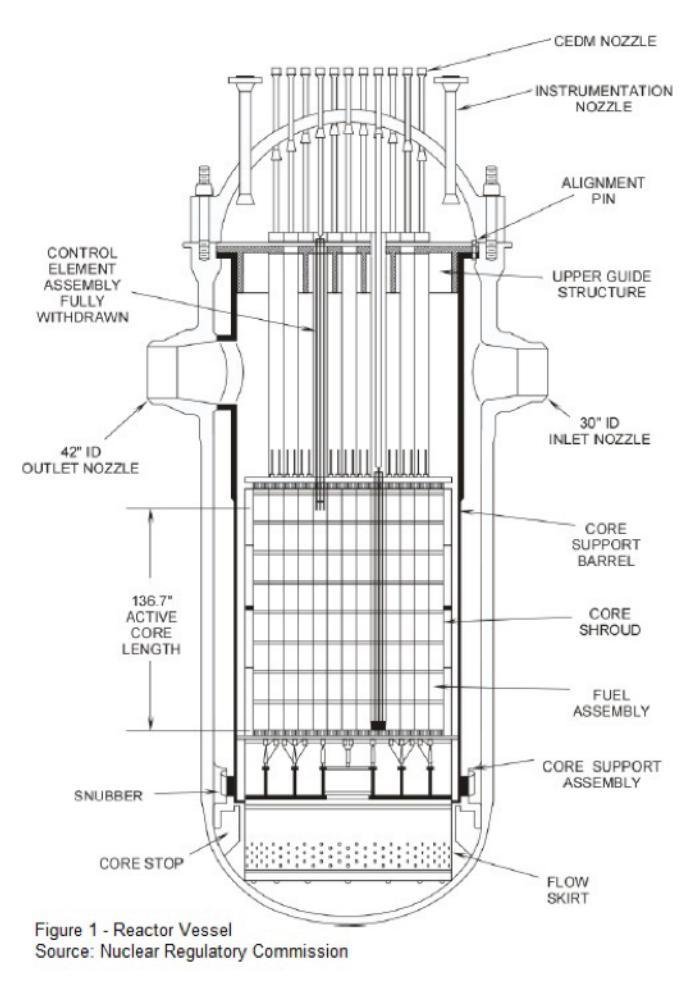
Nuclear fuel assemblies within the reactor core produce the energy used to generate electricity. The core resides inside a large metal pot called a reactor vessel (see Figure 1). A lid, also called the reactor pressure vessel head, is bolted onto the reactor vessel during plant operation and removed during refueling to allow spent fuel assemblies to be replaced with fresh fuel assemblies. Each fuel assembly consists of vertical cylinders filled with uranium pellets. The Palisades reactor has 45 control rods, called control elements in the CE PWR design, interspersed among the fuel assemblies in the reactor core. Withdrawing the control rods increases the reactor's power level, while inserting control rods reduces the reactor's output. Figure 1 shows a control rod on the left that is fully withdrawn from the reactor core into a plenum region above the core, and a control rod on the right that is fully inserted. Control rods may also be partially withdrawn. Long metal shafts connect the control rods to electric motors located on top of the reactor pressure vessel head. The electric motors are used to withdraw or insert control rods. Because the pressure of the water inside the reactor vessel is high – over 2,000 pounds per square inch during operation - seals are installed around the metal shafts to prevent, or at least limit, water leaking from the reactor vessel.

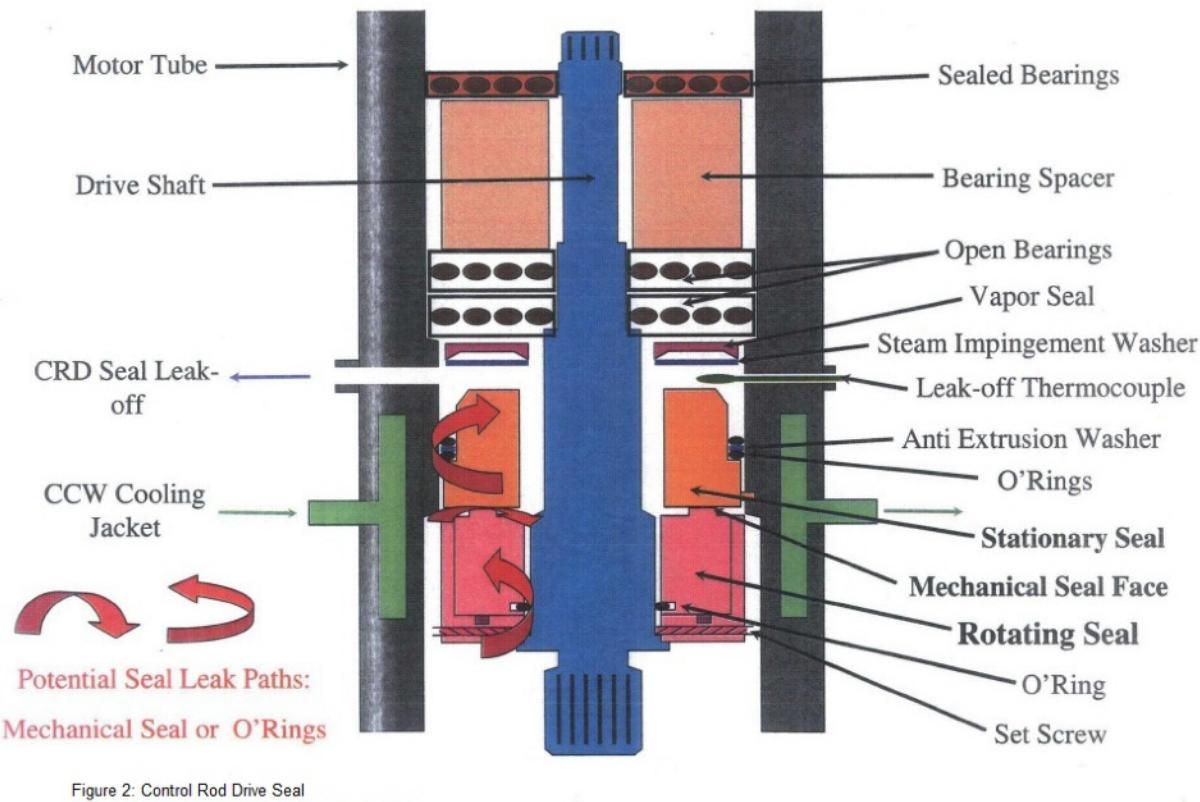
Source: Entergy (March 31, 2010, letter to NRC)

Figure 2 illustrates the seal design used at Palisades. The vertical blue piece in the center represents the metal shaft connecting an electric motor to a control rod. This shaft rotates when the electric motor operates to re-position the control rod, but this portion of the shaft does not move up or down. The bottom of this shaft is connected to another vertical metal shaft via beveled gears. As the blue shaft rotates, the gearing causes the parallel shaft to raise or lower to re-position the control rod. The red pieces toward the bottom are a cutaway view of what is a doughnut-shaped rotating seal that fits between the shaft and the outer metal tube (sometimes called the nozzle). Above this seal is a stationary seal, also doughnut-shaped and shown in orange. Below the seals, the nozzle is filled with

water at reactor pressure. The cushiony nature of the seals allows them to better fill the space between the shaft and the tube. However, the seal hardens and becomes less effective when heated above 250°F. Because the water is at a higher temperature (over 500°F), the region near the seals is supplied with cooling water from the component cooling water (CCW) system, shown in green in the figure. The seals prevent, or at least limit, water from leaking out of the reactor vessel. If water leaks past the seals, it is detected by a "leak-off" thermocouple (or thermometer) shown on the right side. The leaking water is routed to the containment sump via the control rod drive (CRD) seal leak-off line shown on the left side.

In 2008, the company conducted an evaluation to identify the causes of recurring control rod seal leakage. The primary cause was attributed to inadequate seal area cooling. A secondary cause was poor quality of the rotating seals (the red item in the graphic on page 2) and fabrication-related material defects of the stationary seals (the orange item in the graphic on page 2).

The Palisades staff have made numerous attempts over the years to resolve the leaking control rod seal problem. In late 1972, about 18 months after the reactor was licensed by the AEC to operate, workers replaced the rotating seals (the red item in figure 2) on eleven of the 45 control rods with ones made from a different material. That attempt failed and workers replaced the seals on all 45 control rods in late 1974 with ones made from yet another type of material.

During the refueling outage in 2009, workers replaced the seals on all 45 control rods. In addition, workers again modified the ventilation system to provide more cooling air flow to the region of the control rod drive mechanisms above the reactor vessel head.
